## The Problem

## How to Identify

## The Solution

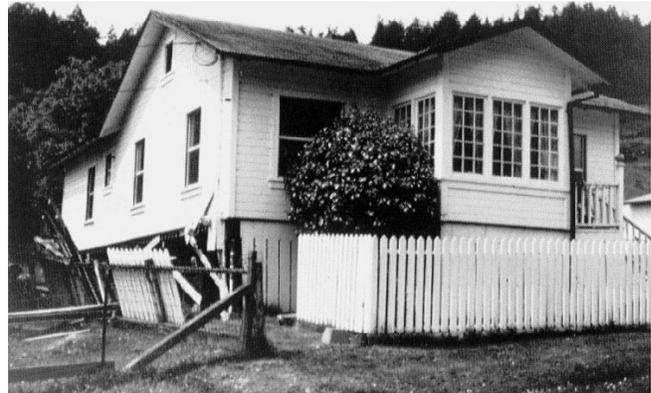
The outside of the house is supported by wood posts resting on unconnected concrete piers. Siding is often nailed to the outside of the posts, making them not easily visible.

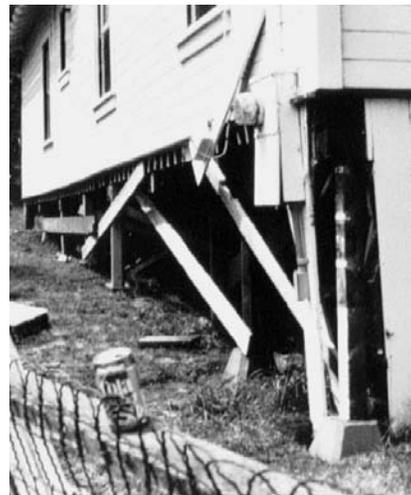
**Figure 15** - The pier-and-post foundation under this home shifted during a recent earthquake.

During an earthquake these posts can fail, if they are not braced against swaying.

If the posts fail, the house may shift or fall.
