The Problem

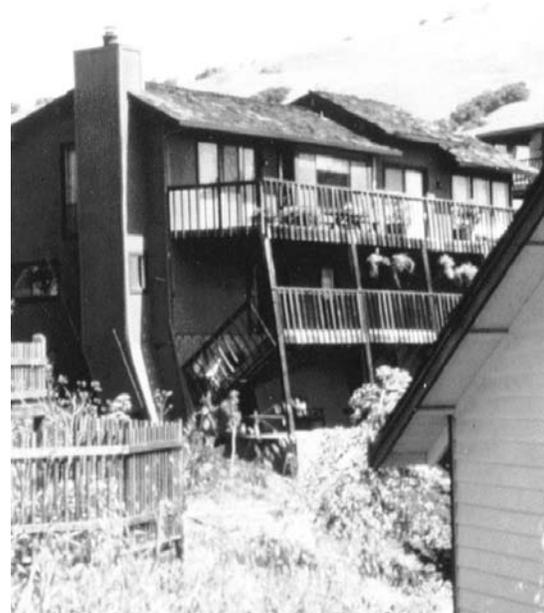
Figure 18 - This hillside home was built on an unbraced tall wall that failed.

Houses built on the sides of steep hills are often set on exposed posts or columns, as shown in the Figures 18 and 19.

If these posts or walls are not properly braced, they may collapse during an earthquake.

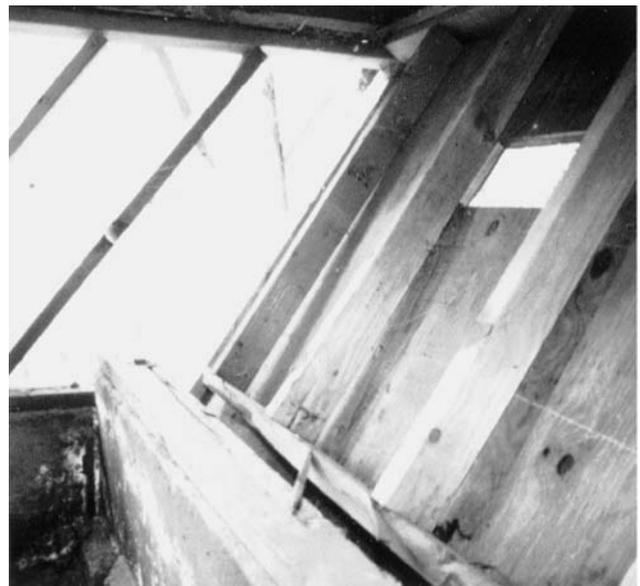
Figure 19 - This photograph shows an interior detail of a home similar to the one above, with substantial damage to a building with an unbraced tall wall.

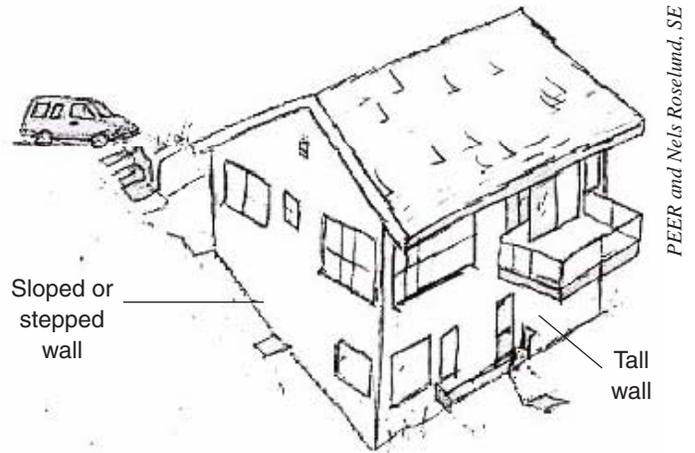
Figure 20 - Hillside homes with sloped and tall walls or posts require special engineering.

Consult a licensed architect or engineer, and a licensed contractor, to fix this problem.
